# TEST REPORT

REPORT No.:  
CTK-2024-00268  
Page (1) / (13) pages

NETWORK CAMERA / TNV-C8011RW

IEC 60529:1989 +A1:1999+A2:2013

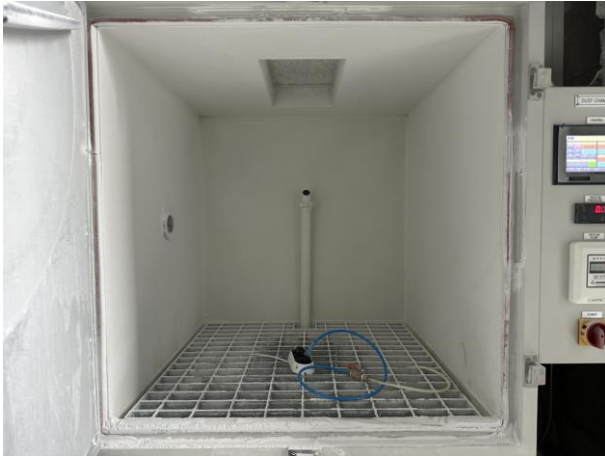
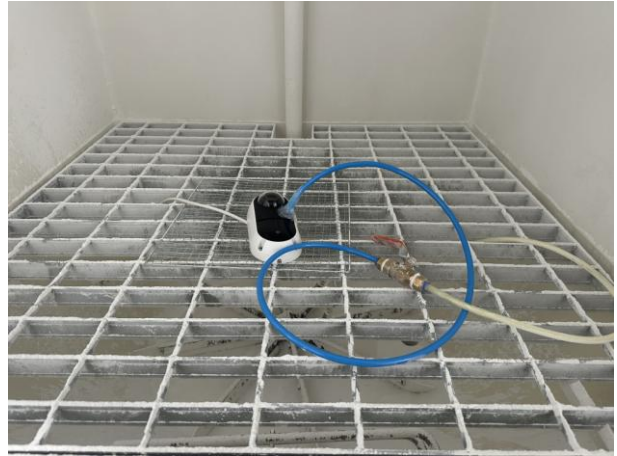
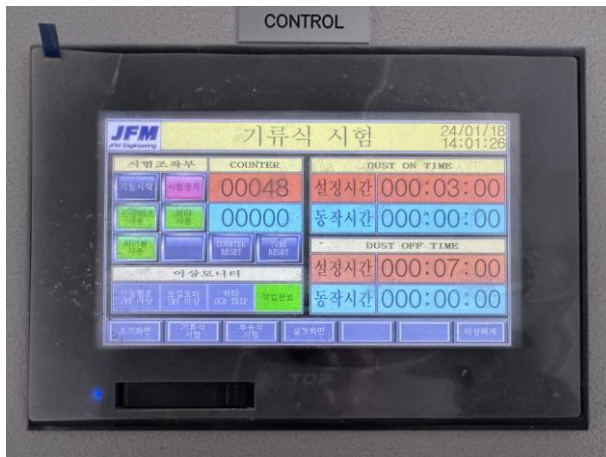
Dust test

Dust test monitor

First characteristic numeral	Degree of protection	Application
6	<p>In Dust Testing Equipment, the test sample has to have no ingress of dust after testing atmospheric pressure present condition for 8 hr.</p> <p>(Talcum powder have to go through the measured sieve by <math>\Phi</math> 50 <math>\mu</math>m wire that are spacing 75 <math>\mu</math>m in squared, per volume and union Talcum powder have to be 2 kg/m<sup>3</sup>)</p> <p>Products in volume .....: <b>760.15 cm<sup>3</sup> → 0.76 L</b></p> <p>Target intake volume (Products in volume 80) .....: <b>60.81 L</b></p> <p>Suction volume (Max product in volume 60) .....: <b>45.61 LPH → 0.76 LPM</b></p> <p>Actual Suction volume .....: <b>0.76 L</b></p> <p>Suction pressure (Up to 2 kPa) .....: <b>1.89 kPa</b></p> <p>Test time (Up to 8 time) .....: <b>8 hr</b></p>	<input checked="" type="checkbox"/>
<sup>1)</sup> The full diameter of the object probe shall not pass through an opening of the enclosure. Due to the simultaneous requirement specified in table 2, the definition “shall not penetrate” is given in table 1.

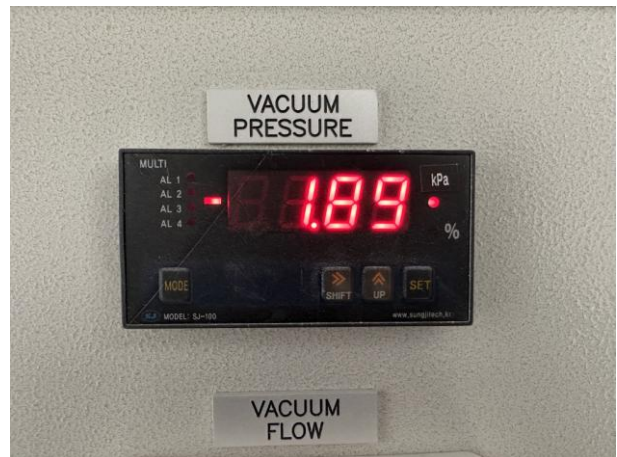
Vacuum pressure

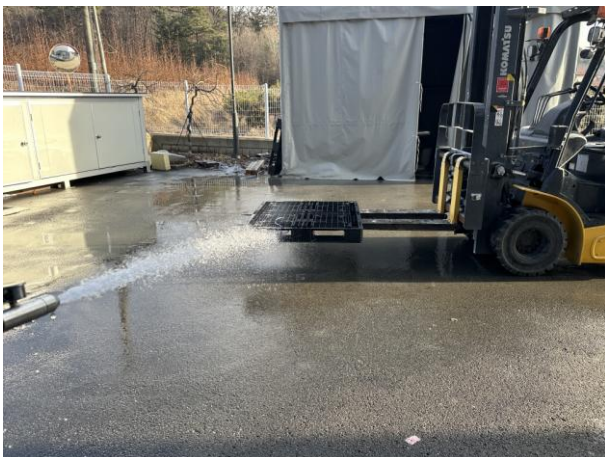
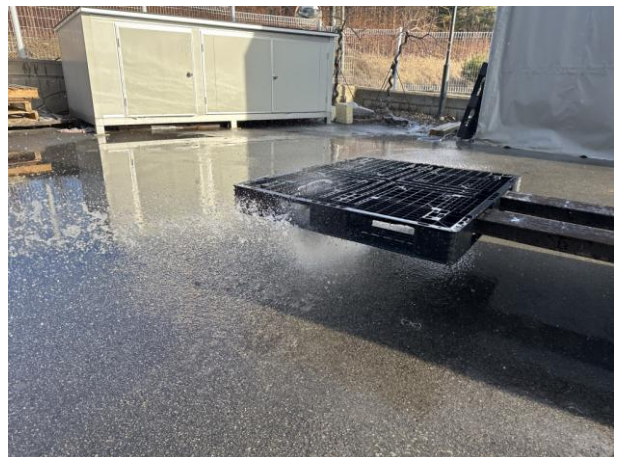
Water test

Second characteristic numeral	Degrees of protection	Application
6	<p>The product must not be harmed in any direction even strong jet water.</p> <p>Water jet hose nozzle Fig.6, Nozzle 12.5 mm diameter</p> <p>Water flow rate: 100 l/min <math>\pm</math> 5 % : <b>100 LPM</b></p> <p>Distance: 2.5 m to 3 m: <b>3 m</b></p> <p>Duration of test: 1 min/m<sup>2</sup> at least 3 min: <b>3 min</b></p>	<input checked="" type="checkbox"/>

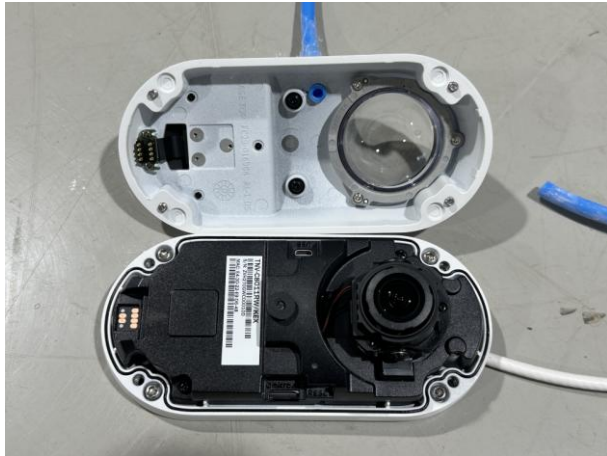
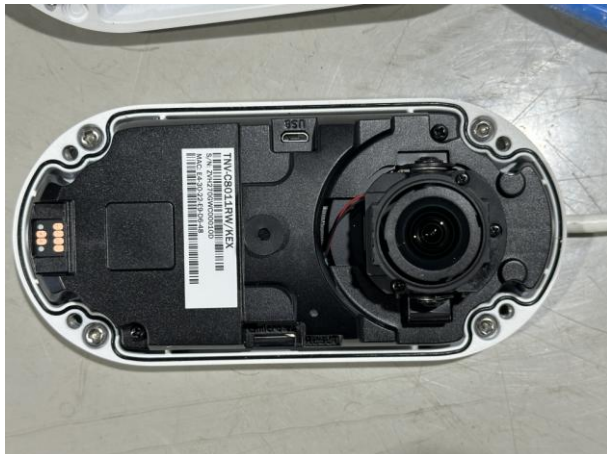
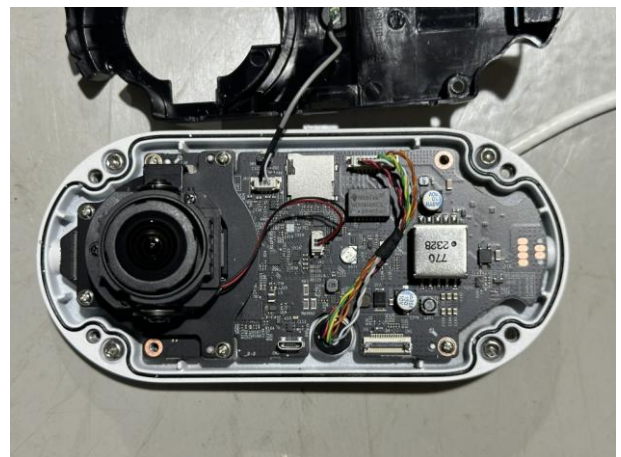
### 4.2.1 Product internal images after test [The First characteristic Numeral Test]

IP code	Evaluation Criteria	Test Results	Remark
IP 6X	No penetration of probe.	<b>Normal</b>	-
	No ingress of dust.	<b>Normal</b>	-
IP X6	No ingress of water.	<b>Normal</b>	-

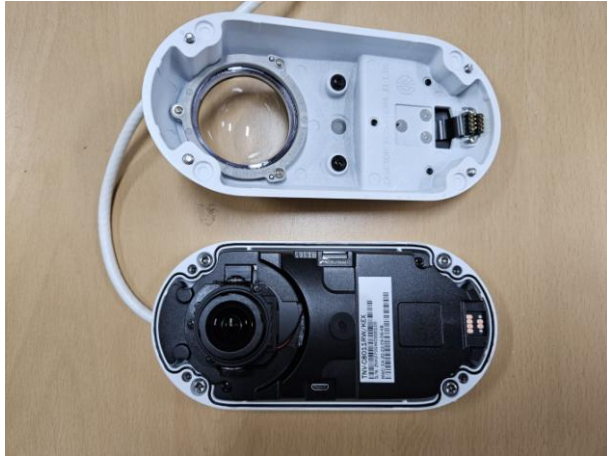
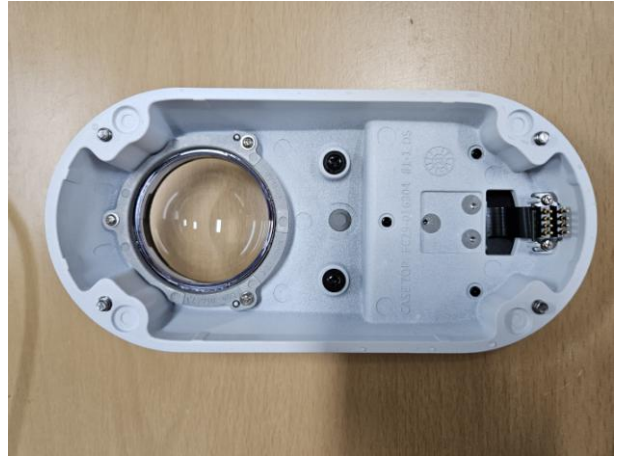
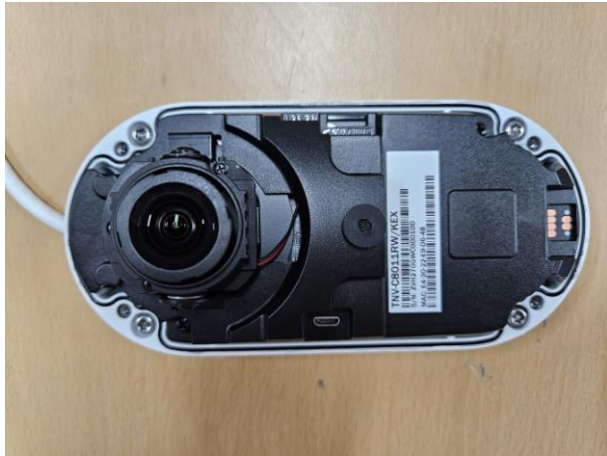
#### 4.2.2 Product internal images after test [The Second characteristic Numeral Test]
